Rehabilitation of Clifton Avenue Reservoir

By Erhard Kruger, BEng (Hons) (Structural), Pretoria and Emuël Kok, BSc (Hons) Engineering Geology, Pretoria

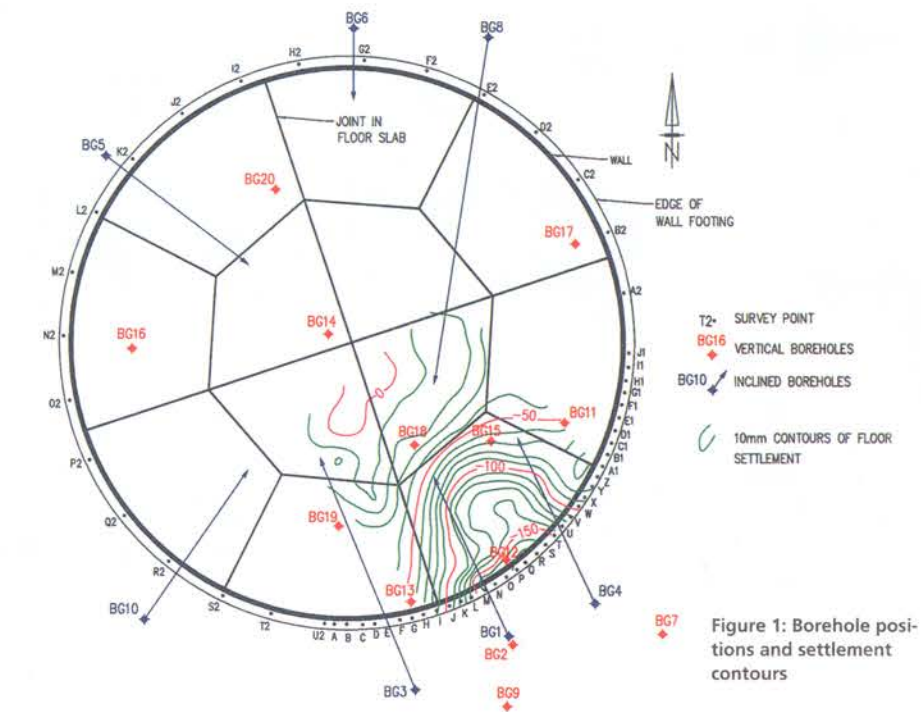
Figure 1: Borehole positions and settlement contours

At first filling of the reservoir after rehabilitation of the bandages during May 1997, leakage was detected on the outside of the reservoir at the wall-to-floor joint, indicating settlement of the floor. A total of 57 monitor points (Figure 1) were installed on the wall footing and records kept over 18 months. Gradual settlement of up to 196mm was observed over about 25% of the floor area. Contours were plotted as shown in Figure 1. Cracks also appeared in the ground surface around the reservoir.

Settlement caused the bandage between the wall and the floor to tear, since the wall behaved like a deep beam, spanning the settled footing. A gap of up to 250mm beneath the settled floor contributed towards the reservoir becoming unserviceable.

In general, air and sample loss occurred as low density zones were encountered. A video camera survey of the holes confirmed that there were no cavities. Investigations suggested that settlement was caused by saturation of the soil, probably due to poor stormwater drainage and leaking pipes. This resulted in leakage of the reservoir and more water being released into the soil, which exacerbated the problem by causing the collapse of low density material and thus further settlement of the overlying material.

Ground improvement was achieved by means of compaction grouting. Cementitious grout was pumped into pre-drilled boreholes under pressure between 1 300kPa at 35 m deep to less than 100kPa at 5m deep. Upstage grouting was done, resulting in compaction of low density material adjacent to the borehole. Primary grouting boreholes were drilled on a 4m grid and secondary boreholes on a 2m grid where required.

Grouting started on the perimeter of the area to be improved. Excessive grout loss necessitated a grout curtain at the perimeter, with boreholes grouted under gravity.
